Installation Story #11 Foamfrax® Insulation

Industry: Chemical Process Industry (CPI)
Location: Gulf Coast, United States
Installation Date: November 2001
Operating Temperature: 2150°F (1176°C)
Scope of Job: Ethylene Furnace, Lummus Design,
56 John Zink Flat Flame Burners per Sidewall
Foamfrax Grade II Insulation 2" (50mm) Veneer Over Insulating
Firebrick Natural Gas Fired, Continuous Operation

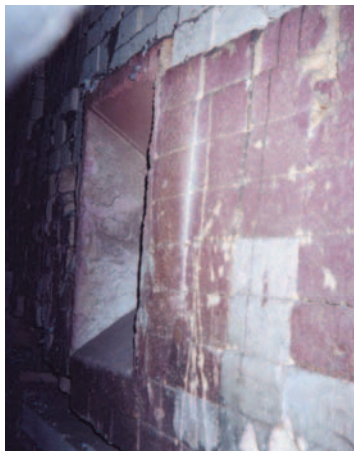
The existing hard refractory furnace lining had been in service for over 20 years. Due to constant in-service temperature and periodic thermal cycling, refractory repairs were required during each furnace shutdown. Complete tear out and refractory replacement would involve a major capital investment and significant furnace down time.

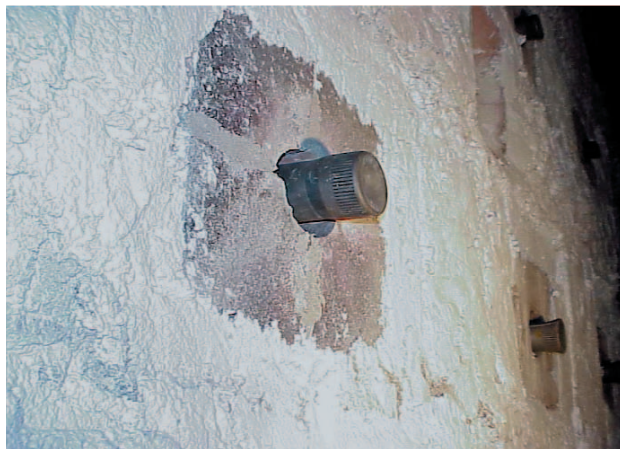
Foamfrax Insulation was easily gunned over the existing hard refractory lining. The only surface preparation required is to remove all loose/unstable refractory and apply a surface coating of dilute Fiberstick™ Refractory Cement to the hard refractory substrate. The Foamfrax Insulation was easily troweled as required around burner locations, so as to not interfere with the flat flame burner pattern.

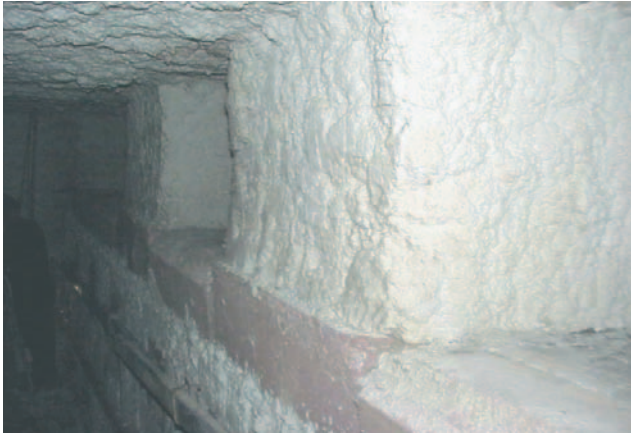
Foamfrax Insulation affords the benefit of adding additional insulation to areas traditionally difficult to insulate such as chimney support columns. With installation rates of 1000 board feet/hour, Foamfrax Insulation is quickly installed.

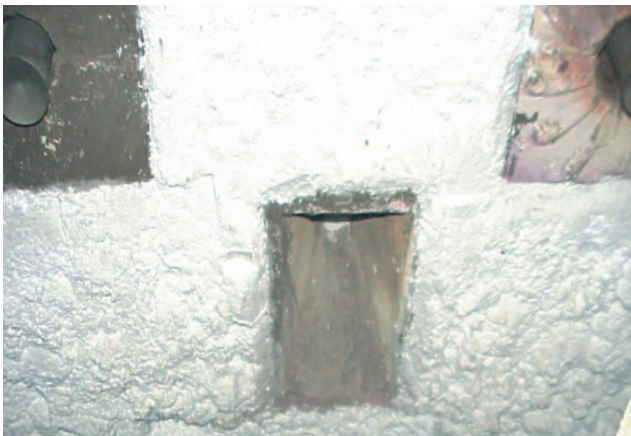
Foamfrax Insulation installs easily around burner locations, sight windows, and other furnace lining penetrations. The net result is an efficient ceramic fiber veneer to repair degraded refractory and increase furnace efficiency.
