Installation Story #4 Foamfrax® Insulation

Industry: Steel
Location: Midwest United States
Installation Date: January 2001
Operating Temperature: 2100°F (1150°C)
Scope of Job: Castable Refractory Lined Ladle Preheat Stand
3" (76mm) 8 PCF (128 kg/m³) Foamfrax Grade II Fiber Veneer

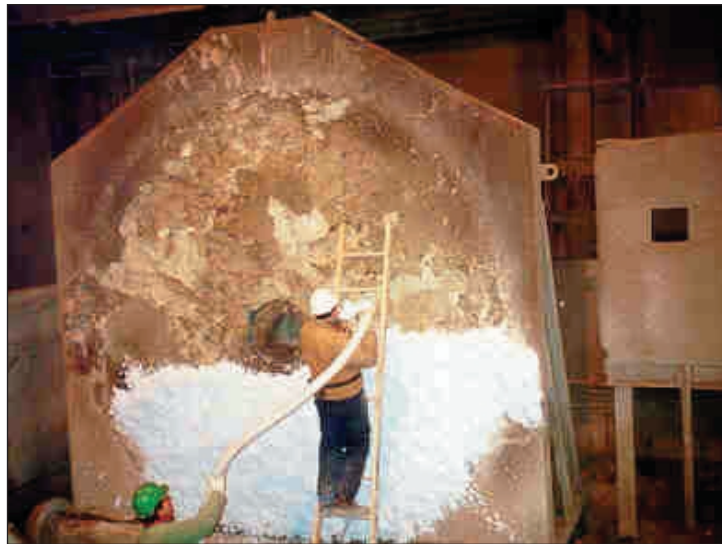
The refractory lining for this ladle preheat stand had become chipped and uneven due to thermal cycling and mechanical abuse. A veneer of Foamfrax Insulation was used to even out the lining and extend its life. Prior to installation, the refractory was wet with water to lower the refractory surface temperature below 200°F and all loose refractory material was chipped away. For the removal of any after service refractory material, refer to the product MSDS for proper material handling guidelines. All applications of Foamfrax Insulation over hard refractory materials should utilize a wash coat of Fiberstick™ cement on the refractory to optimize adherence. Please note that Foamfrax Insulation will not adhere to surfaces with temperatures in excess of 200°F.

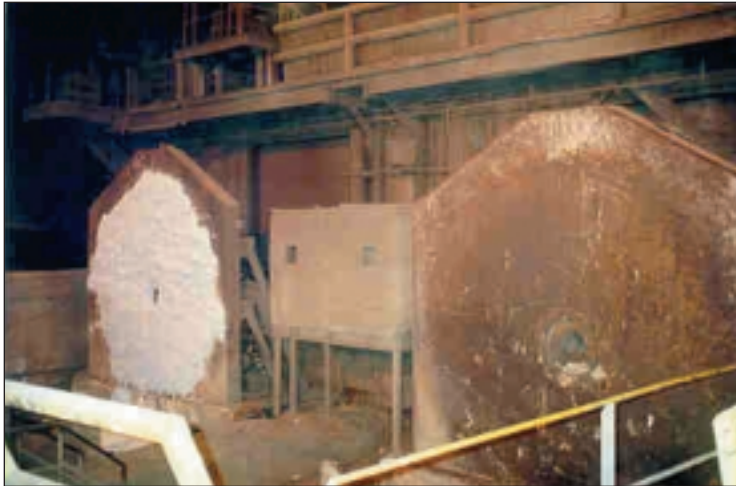
After the installation was complete, the insulation on the ladle stand was built back to its original thickness. All voids and cracks in the refractory had been filled.

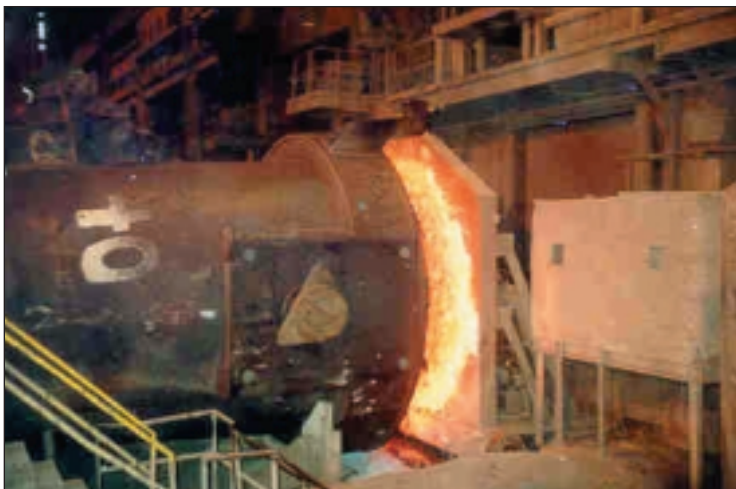
The ladle stand was put into service immediately after installation. Foamfrax Insulation does not require any special heat-up/cure-out cycle.
