Installation Story #34 Foamfrax® Insulation

Industry:	Steel
Location:	Midwest United States
Installation Date:	August 2006
Type of Unit:	Roller Hearth Furnace
Operating Temperature:	2250°F
Scope of Job:	3" Foamfrax Grade III HD 6" Foamfrax Grade I

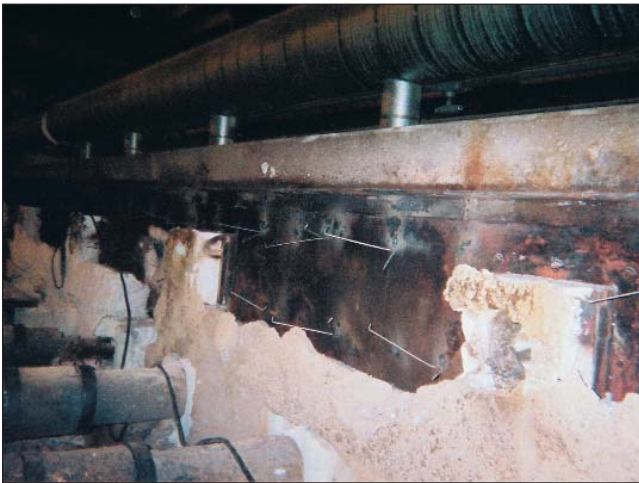
The existing ceramic fiber module lining in the entrance section of this roller hearth furnace had deteriorated due to chemical attack. Foamfrax Grade III HD was chosen for the hot face material in this application because its 72% Al_2O_3 content and higher density provided good flux resistance properties.

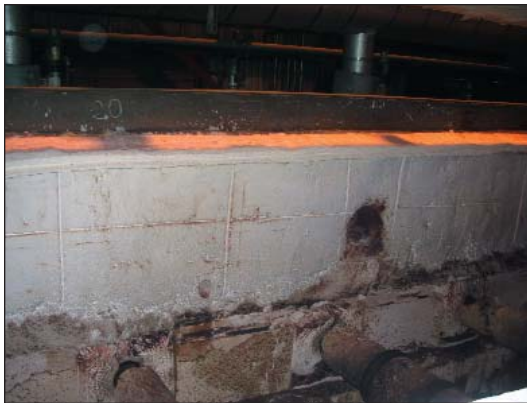
After 6 months of service, the Foamfrax composite lining system shows no signs of degradation or chemical attack.
