## Installation Story #22 Foamfrax® Insulation

Industry:	Steel
Location:	East Coast United States
Installation Date:	July 2003
Type of Unit:	Carbottom Reheat Furnace
Operating Temperature:	2200°F (1205°C)
Scope of Job:	Furnace Roof, Sidewalls, and End Wall Sections 2" (51mm) Foamfrax Grade II Fiber Veneer Installation, over Chrome Modules

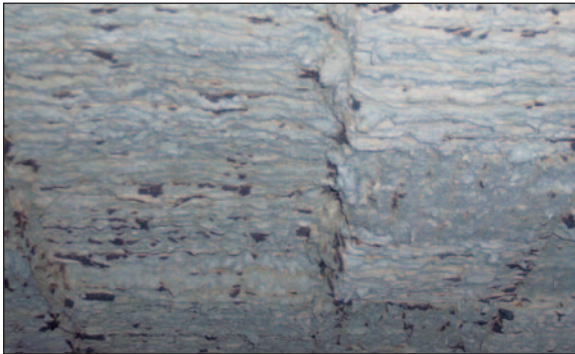
The roof section had shrinkage to the extent that the lining thickness had been reduced by 2" (51mm). There was also a buildup of oxidized material on the face of the modules. Prior to the installation of Foamfrax Insulation, the lining was wet with water and then scraped down to expose clean fiber. Approximately 1" of the surface needed to be removed before all devitrified fiber was removed.

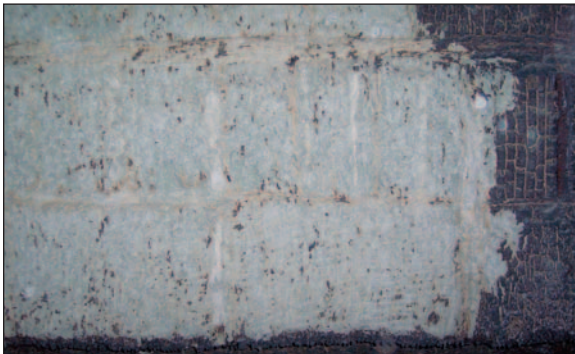
The end wall was in the same condition as the roof. There was less shrinkage than on the roof, but the iron oxide buildup on the sidewalls was considerably worse. Approximately 1½" (38mm) had to be removed from the face of the modules in order to provide a suitable substrate for the Foamfrax Insulation.

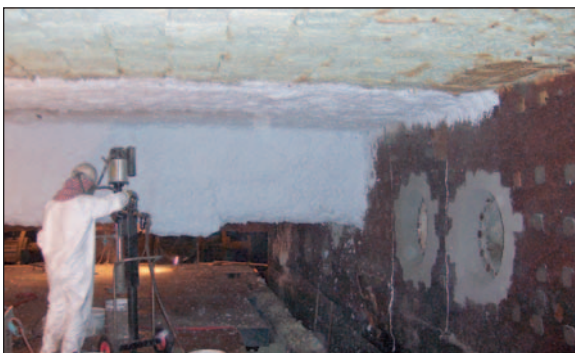
On the rammed plastic refractory sidewalls, there was no significant shrinkage; however, the dust, debris, and oxide deposits were evident. The sidewalls were sprayed with a water stream first and then brushed off using push brooms. This was followed by another spray application of water in order to achieve a clean surface for the installation. Fiberstick™ prep was used on all surfaces and was applied using an ARO pump. The use of the ARO pump allows for more control of the Fiberstick solution, produces less waste, and is easier than using a hopper gun.

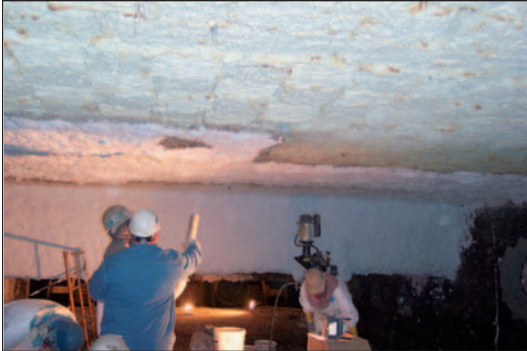
Because of the shrinkage in the roof sections, the customer was experiencing unusually high cold face temperatures. The Foamfrax Insulation was installed 2" (51mm) thick on all surfaces. This returned the lining to the original thickness, and as a result, lowered the cold face temperature.
