UNIFRAX APPLICATION STORY

Product Solutions: Silplate Mass 1500
Industry: Ferrous
Applications: Reheat Furnace - Repair to walls
Location: Brazil

NOVEMBER 2018

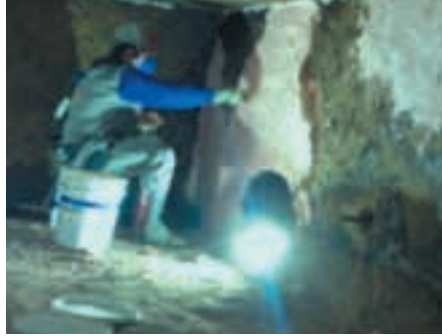
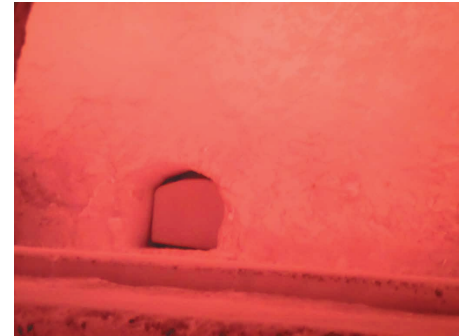
Internal view—no loss of Silplate Mass 1500 since December 2014

The Silplate Mass 1500 repair solution has been in place since December 2014. There has been no loss of the mastic coating and it has not required any maintenance during its service life.

Silplate Mass 1500 was successfully applied using a trowel to fill any gaps or cracks within the refractory lining of the walls of the furnace. Finally a 10mm thick coating of Silplate Mass 1500 was applied over the lining surface.

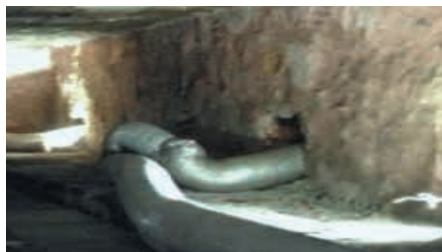
Furnace walls after installation
