## Installation Story #10 Foamfrax® Insulation

Industry:	Steel
Location:	Northeast United States
Installation Date:	May 2001
Operating Temperature:	2300°F (1260°C)
Scope of Job:	Batch Forge Furnace Foamfrax Insulation Full Thickness Composite System, 13½" (343mm) 7" (178mm) Foamfrax Grade I Fiber, 8 PCF (128 kg/m <sup>3</sup> ) 6½" (165mm) Foamfrax Grade II Fiber, 8 PCF (128 kg/m <sup>3</sup> )

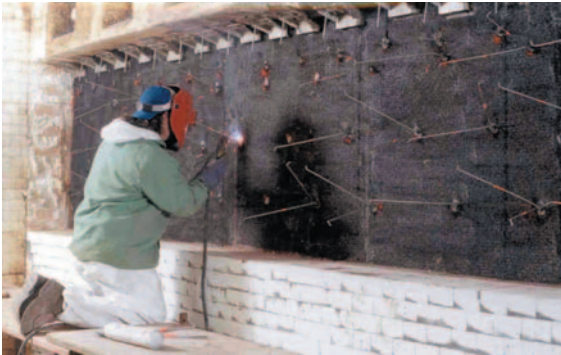
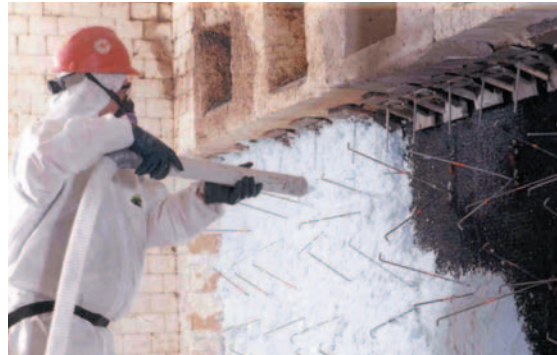
Due to repeated thermal cycling, the insulating firebrick sidewall of this batch forge furnace had begun to deteriorate. A new brick bench was installed and Foamfrax Insulation was selected for a 4' x 25' wall section below the sidewall burners. For full thickness Foamfrax Insulation applications, plastic "spider netting" is adhered to the furnace shell and "V" anchors welded in place through the netting. Note that alloy support plates were welded in place to carry the weight of the plastic refractory burner row above the Foamfrax Insulation.

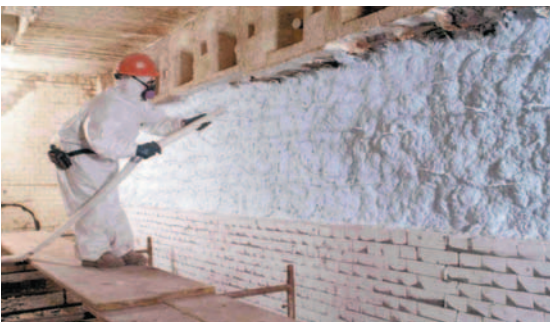
Foamfrax Grade I Fiber was then gunned into the spider netting and around the anchors. The impact velocity and homogeneous consistency of Foamfrax Insulation allow it to flow/work around the "V" anchors without leaving pockets/voids in the lining system. The Foamfrax Grade I Fiber was installed to a 7" (178mm) thickness.

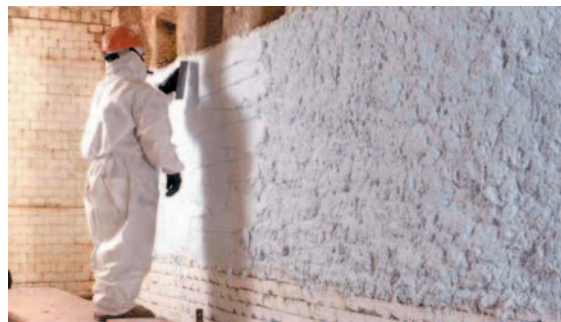
The balance of the wall section (6½", 165mm) was installed using Foamfrax Grade II Fiber. The transition from Foamfrax Grade I Fiber to Foamfrax Grade II Fiber took place at the machine where bags of Foamfrax Grade II Fiber were added.

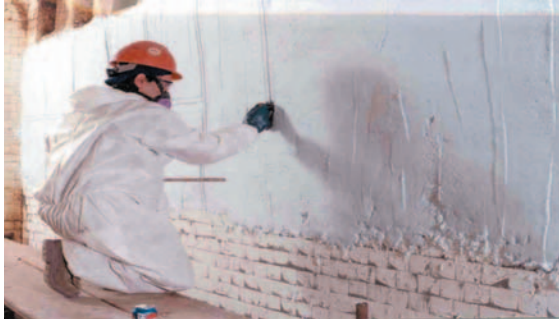
For full thickness applications, the hot face surface must be troweled. A low density (foamy) surface coating of Foamfrax Grade II Fiber was applied and the hot face troweled smooth.

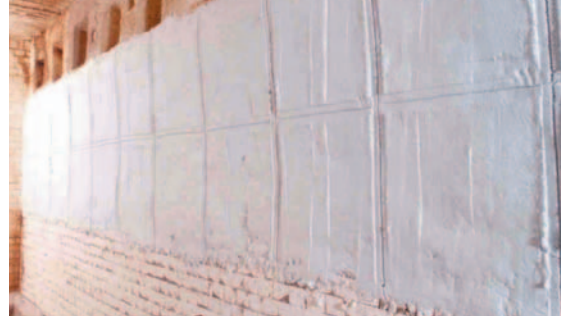
To control surface cracking of the Foamfrax Insulation, score marks were made on a 2' x 2' (610mm x 610mm) grid using a masonry "groover" trowel, similar to the type commonly used for concrete expansion joints.

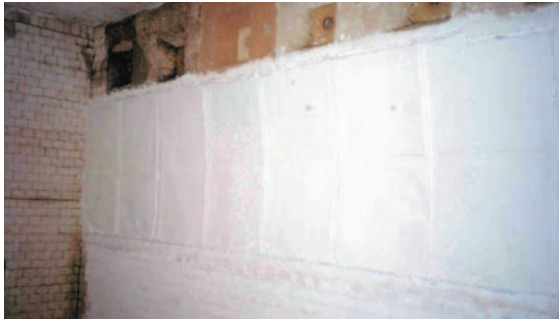
Once the score marks were completed, the furnace was available for use. After the anchors had been welded in place, actual installation of this multi-layer, 1350 board foot application took less than two hours to complete.

This photograph was taken after 3 months of service at 2300° F (1260° C). Controlled cracking did occur at the score marks. The actual cracks were approximately  $\frac{1}{8}$ " wide and extended  $\frac{1}{4}$ " -  $\frac{1}{2}$ " into the lining. Taken cumulatively, this represents less than 1% shrinkage for the system installed.
