## Installation Story #10 Foamfrax™ Insulation

Industry:	Steel
Location:	Northeast United States
Installation Date:	May 2001
Operating Temperature:	2300°F (1260°C)
Scope of Job:	Batch Forge Furnace Foamfrax Insulation Full Thickness Composite System, 132”(343mm) 7”(178mm) Foamfrax Grade I Fiber, 8 PCF (128 kg/m <sup>3</sup> ) 62”(165mm) Foamfrax Grade II Fiber, 8 PCF (128 kg/m <sup>3</sup> )

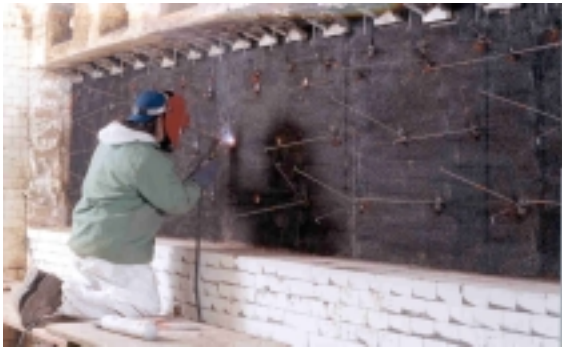
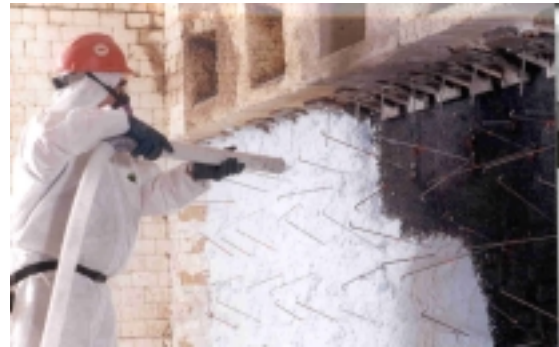
Due to repeated thermal cycling, the insulating firebrick sidewall of this batch forge furnace had begun to deteriorate. A new brick bench was installed and Foamfrax Insulation was selected for a 4'x25' wall section below the sidewall burners. For full thickness Foamfrax Insulation applications, plastic “spider netting” is adhered to the furnace shell and “V” anchors welded in place through the netting. Note that alloy support plates were welded in place to carry the weight of the plastic refractory burner row above the Foamfrax Insulation.

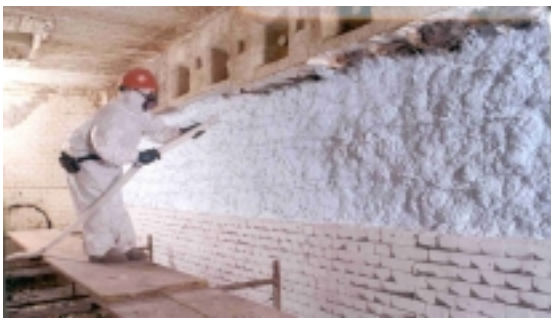
Foamfrax Grade I Fiber was then gunned into the spider netting and around the anchors. The impact velocity and homogeneous consistency of Foamfrax Insulation allow it to flow/work around the “V” anchors without leaving pockets/voids in the lining system. The Foamfrax Grade I Fiber was installed to a 7” (178mm) thickness.

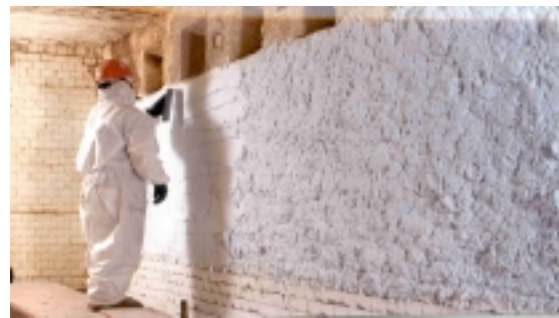
The balance of the wall section (62”, 165mm) was installed using Foamfrax Grade II Fiber. The transition from Foamfrax Grade I Fiber to Foamfrax Grade II Fiber took place at the machine where bags of Foamfrax Grade II Fiber were added.

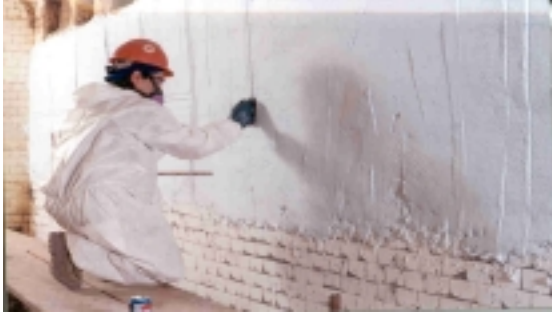
For full thickness applications, the hot face surface must be troweled. A low density (foamy) surface coating of Foamfrax Grade II Fiber was applied and the hotface troweled smooth.

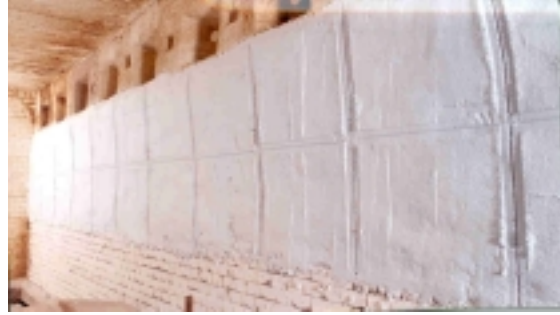
To control surface cracking of the Foamfrax Insulation, score marks were made on a 2' x 2' (610mm x 610mm) grid using a masonry "groover" trowel, similar to the type commonly used for concrete expansions joints.

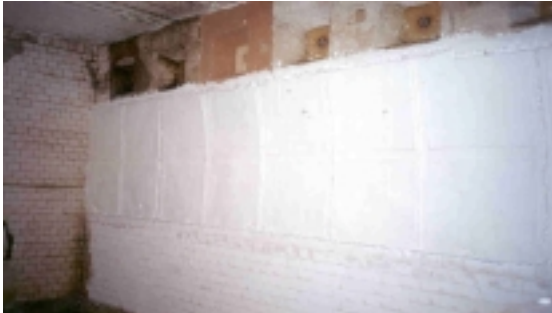
This photograph was taken after 3 months of service at 2300° F (1260° C). Controlled cracking did occur at the score marks. The actual cracks were approximately  $\frac{1}{8}$ " wide and extended  $\frac{1}{4}$ "-  $\frac{1}{2}$ " into the lining. Taken cumulatively, this represents less than 1% shrinkage for the system installed.
